# **SPECIALIZED ENGINEERING AND CONSTRUCTION COMPANY**

# COMPANY PROFILE

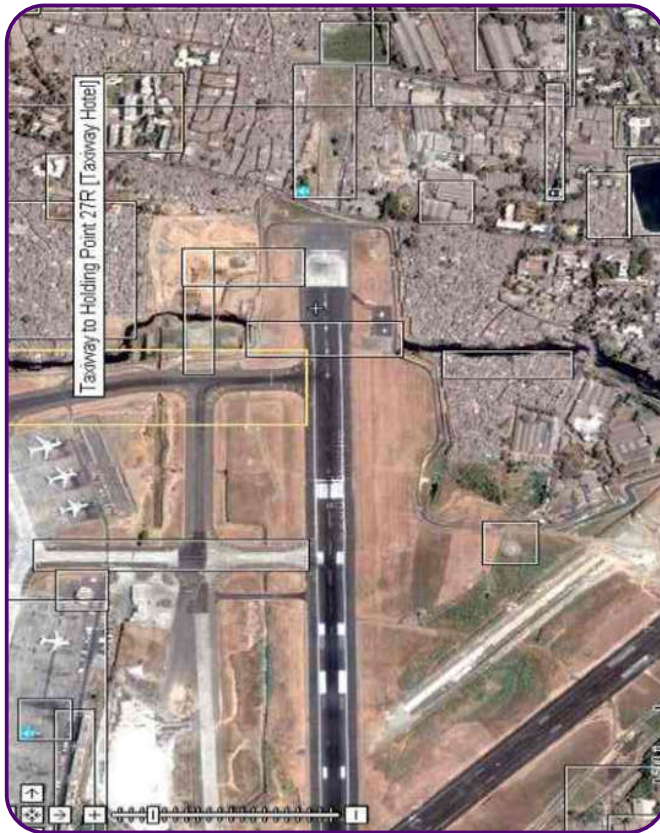
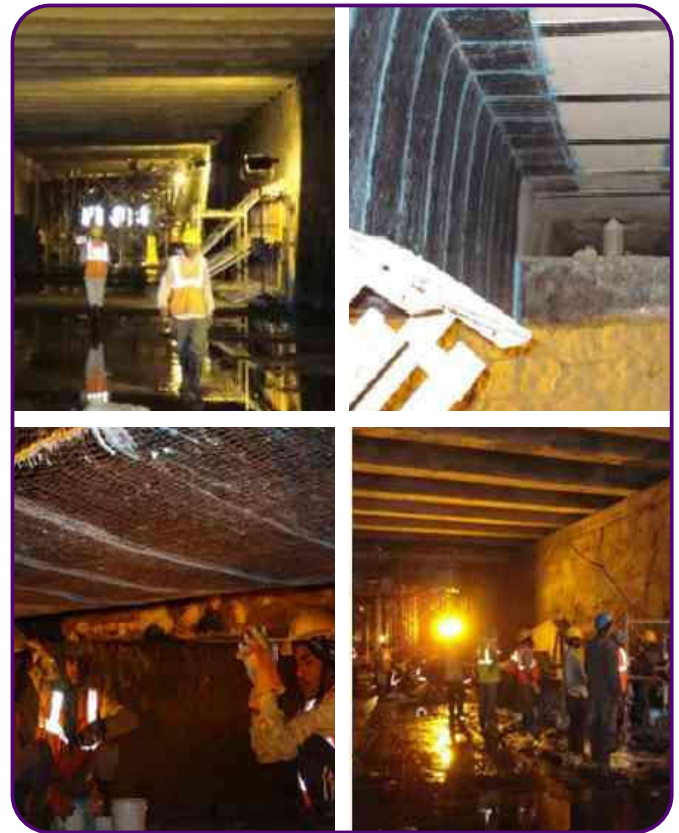
### Runway Bridge, Mumbai Airport

- A bridge at Mumbai Airport over Mithi River was initially designed for smaller aircraft loads. However, loads of new aircrafts were heavier and hence there was need for strengthening of this bridge.
- The analysis has shown, maximum moment at the support is found to be 351T-m and in the span 356T-m. Carbon laminates are used for the purpose of strengthening of beams for flexural demand.

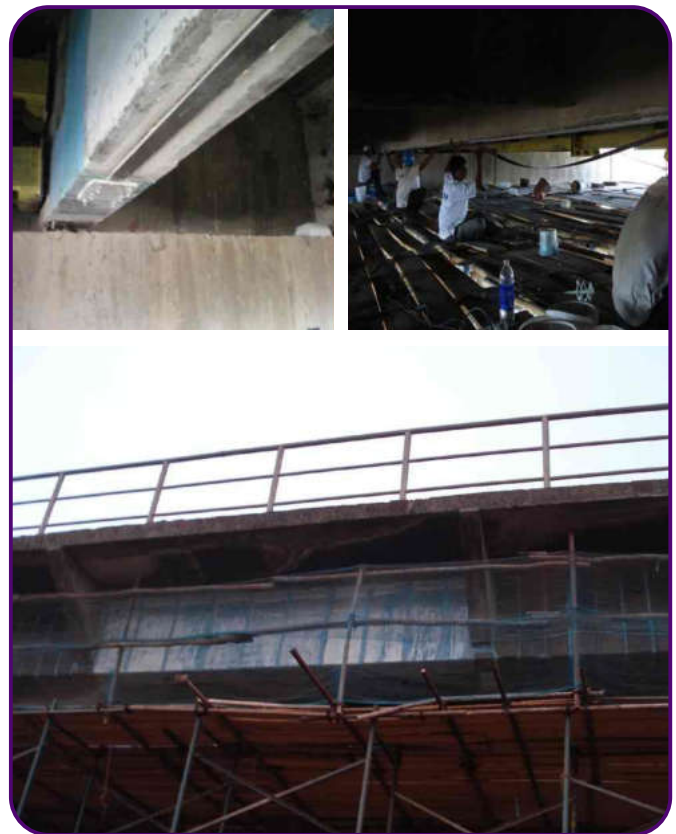
## Rail Over Bridge (ROB) At Karal

- The Rail Over Bridge at Karal had heavy traffic movement and had started showing signs of distress. The bridge was initially designed for IRC 45R loading. As per the revised recommendations of IRC and prevailing practice, the bridge was required to sustain IRC Class 70 R loading.
- Existing RC girders were rehabilitated using CFRP laminates and additional steel truss system was introduced to relieve the forces from RC girders. After strengthening, it was demonstrated using health monitoring sensors that there is reduction of 8.5% in fundamental frequency of vibration. In addition to this, the amplitude of acceleration was reduced by 50%. An average reduction of 26% in the deflection of bridge superstructure under standard loads was also recorded.

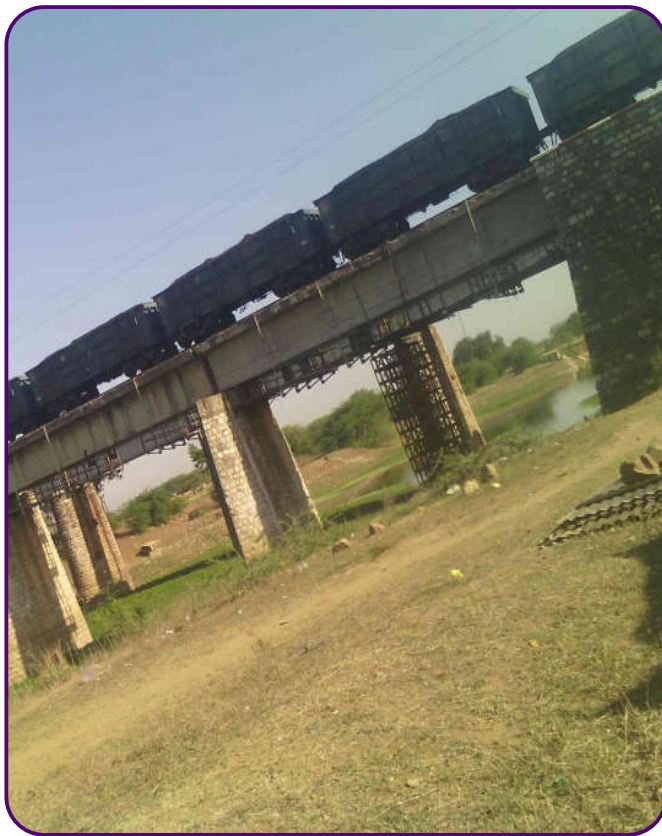
## Rail Over Bridge (ROB) At Ratlam

- Western Railway has proposed rehabilitation of PSC I girders on Bridge of Godhra-Ratlam section of Ratlam Division of Western Railway, India. The Bridge has been observed to require immediate strengthening.
- The main reason for retrofitting of the PSC I girders on the bridges was due to development of cracks on the girders. These cracks were active and were further propagating.
- After strengthening, it was demonstrated that there is an average 71% reductions in deflection in the cracked girder and improvement in natural frequency by 25%. Speed restriction was put for 20 kmph, after strengthening the trains are allowed at 100kmph thereby saving 17mins between Godhra and Ratlam.

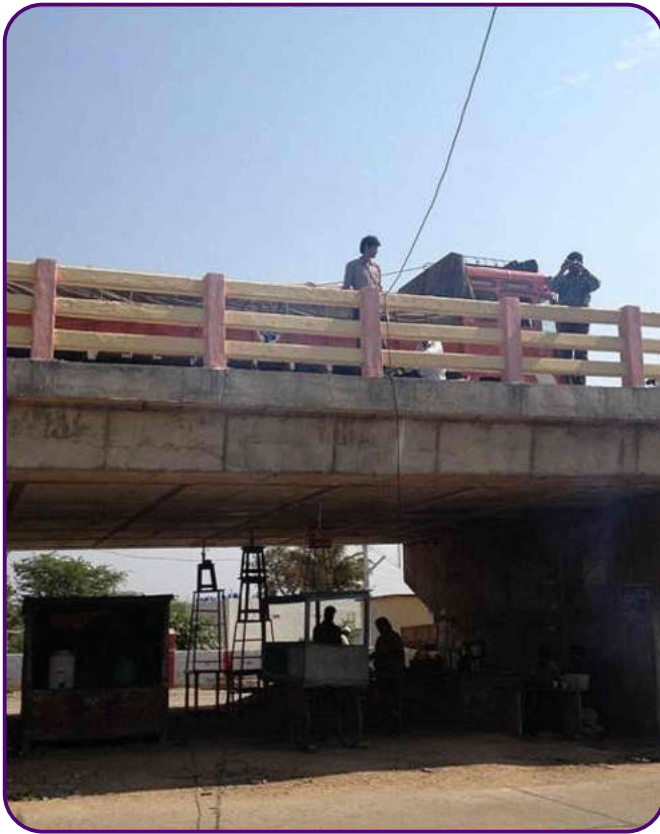
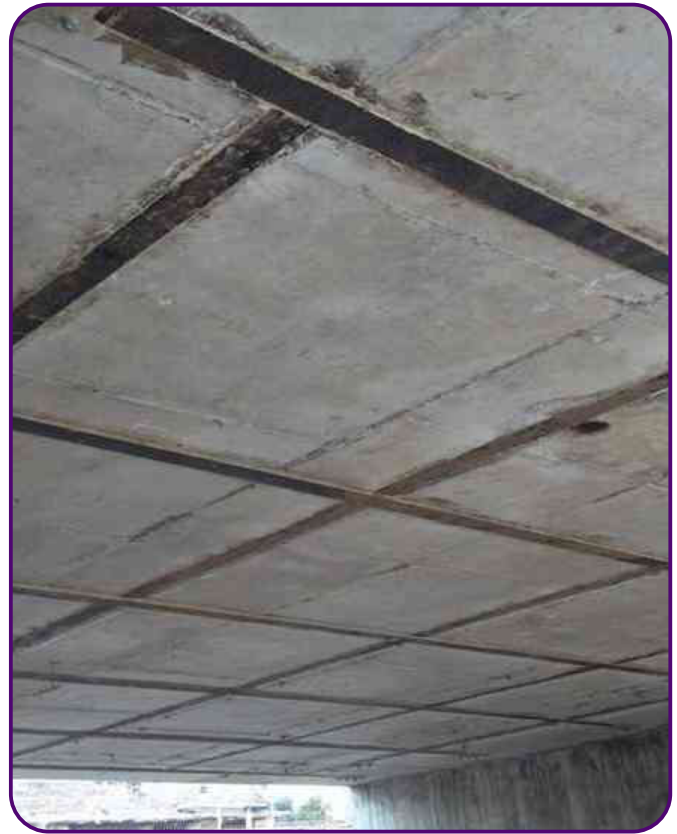
## Rail Over Bridge (ROB) At Ramavaram, Andhra Pradesh

- The construction of ROB located near Ramavaram village at KM 37/2 on podili-Markapuram road, Prakasham District, Andhra Pradesh was started in February, 2009.
- The bridge needed to be rehabilitated due to structural reinforcement deficiency. CFRP laminates were utilised to compensate for the additional reinforcement demand in 13 spans which were already constructed and operational.

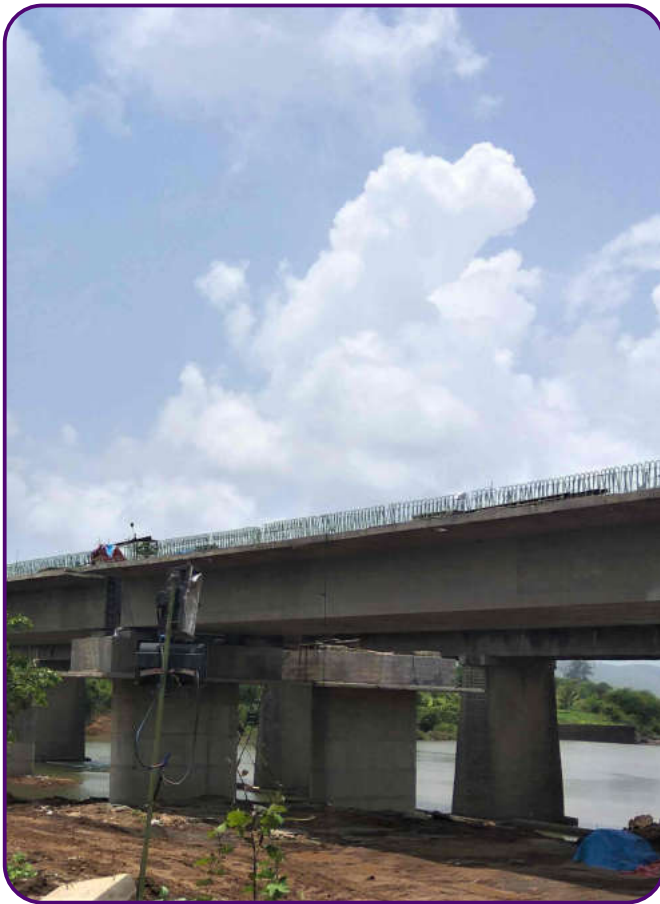
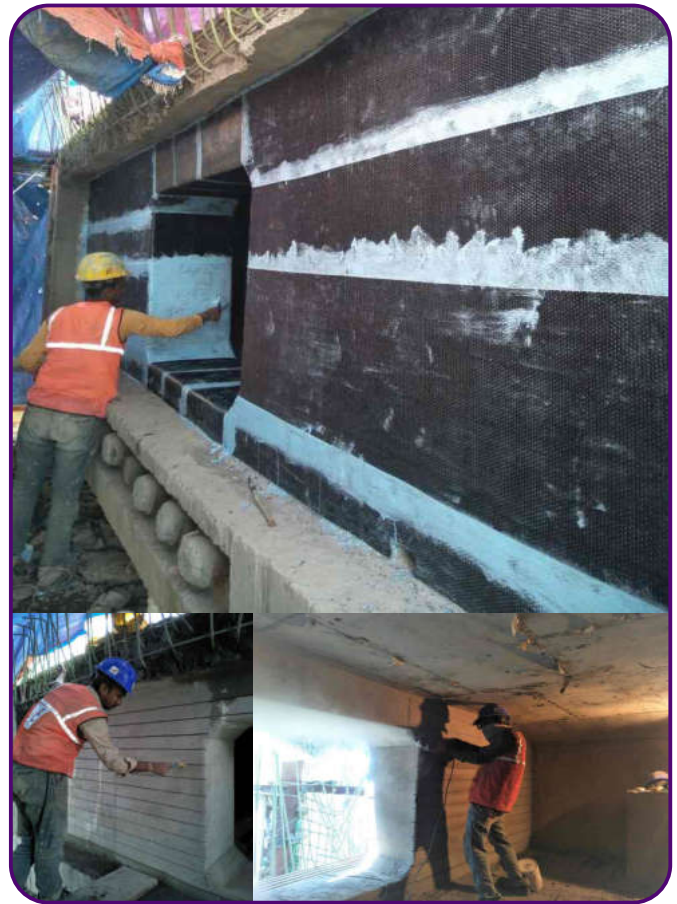
## Segmental Bridge At Boisar

- The bridge across Surya river Boisar Mumbai was in under construction stage when it was found distressed. Cracks were generated in the segment as soon as PT tendons were stressed during post tensioning. These minor cracks had been necessary to be rectified to prevent secondary effects further.
- Groove Laminates and R&M Wraps were employed to address the loss in strength due to crack generation.

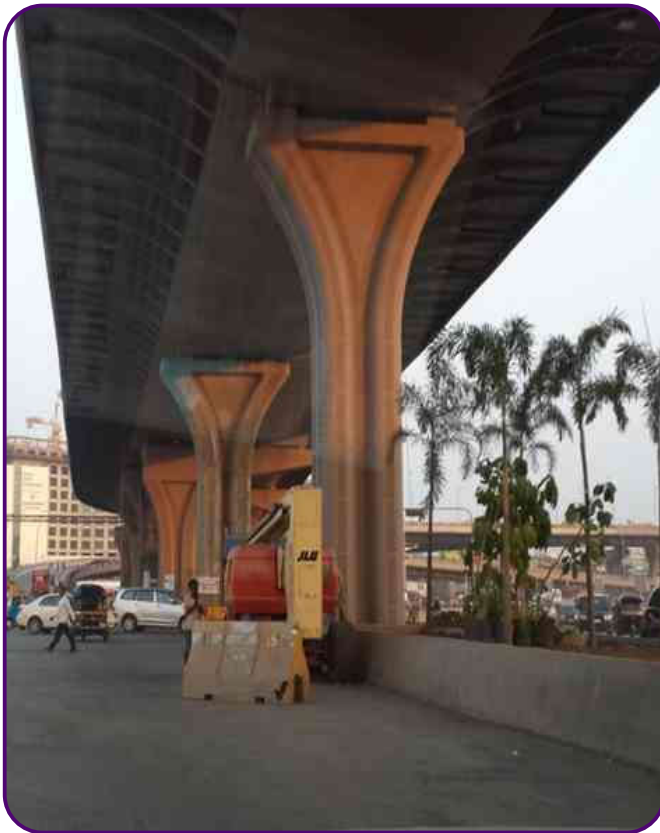
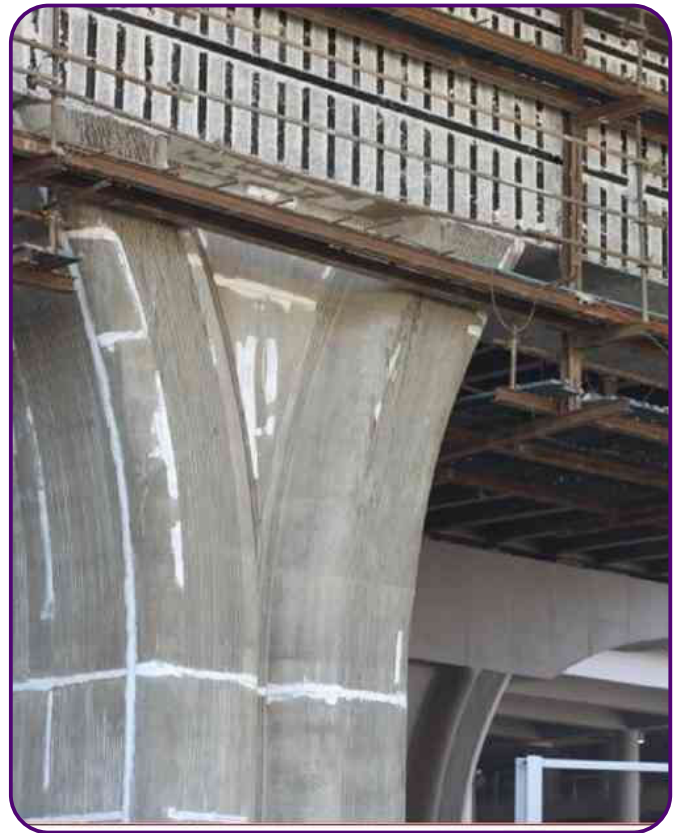
## Bridge Pier In Mumbai

- The Sahar Elevated Access Road connects the western express highway near Hanuman Nagar junction in Vile Parle, with the forecourts of terminal T2 of the Mumbai Airport.
- The portal beam was retrofitted with prestressed CFRP laminates for additional flexural demand. Further in the pier cap there was strengthened using CFRP sheet wrapping and laminates.
- Flyover Inauguration date was announced before the problem could encounter. Team worked day and night to complete the work within the inaugural date. A special U shape pre-stressing was performed on pier cap.

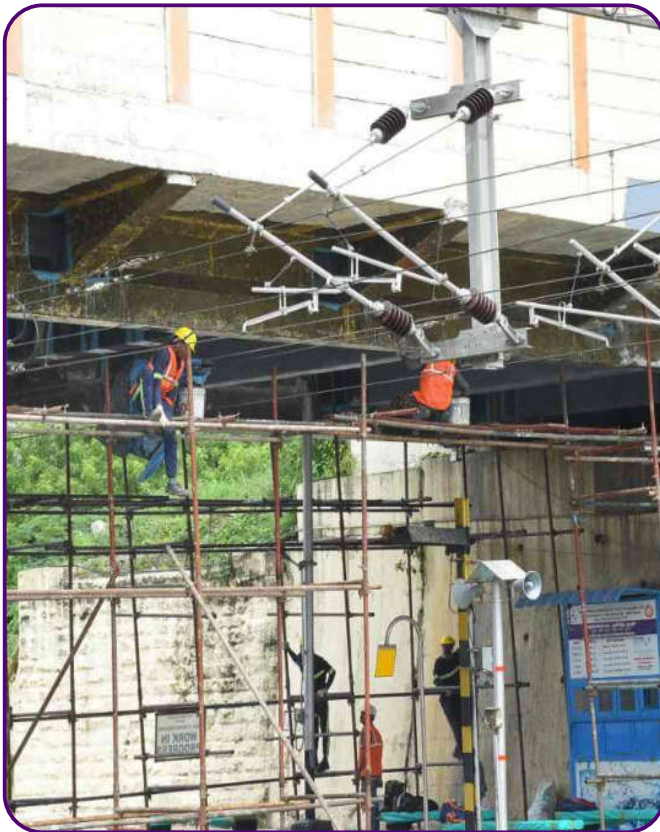
## Bow-string ROB At Katpadi

- The Rail Over-Bridge structure at Katpadi Junction is completed in the record time. DGC was awarded strengthening of Rail Over-Bridge structure at Katpadi major railway Junction which connects major cities like Chennai, Bangalore, Tirupathi and few others. The strengthening of the same is carried out without much disturbance to road and railway traffic. In a two hours block time provided, the team erected temporary staging, perform strengthening activity and dismantle the staging giving clearance to railway traffic. The project was completed within the given railway blocks.
- Pre-strengthening and Post Strengthening tests were performed to record and demonstrate the effectiveness of activated R&M laminate system.

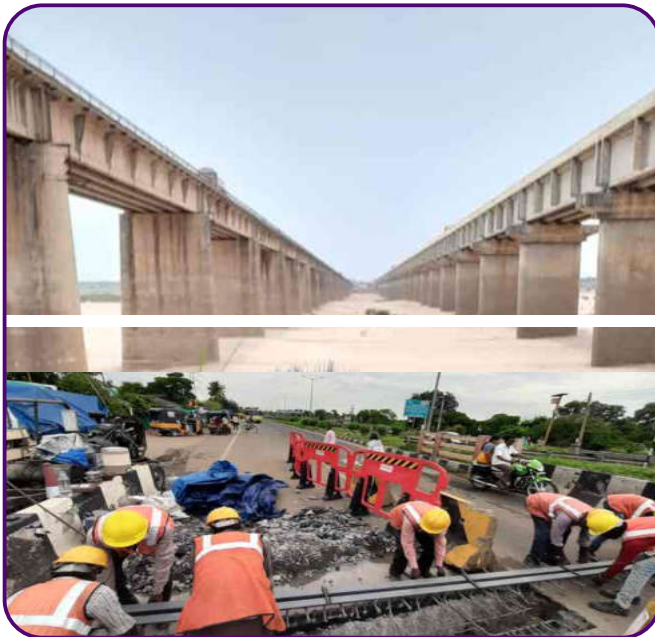
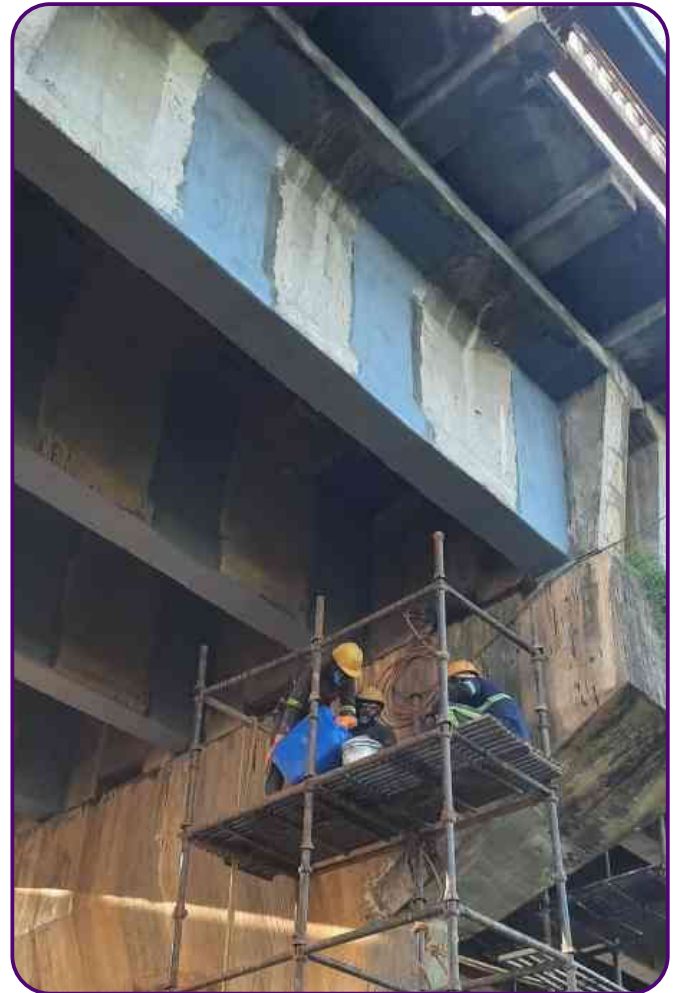
## Bridges At Vishakapattanam

- DGC was awarded the specialized repair work for 783 structures which included Major Bridges, Minor Bridges, Culverts, ROBs etc. spanning from Rajahmundry to Gundugolanu & Puintola to Ichchapuram. All 783 structures were completed with 1 year only thereby setting a remarkable bench mark in infrastructure space.

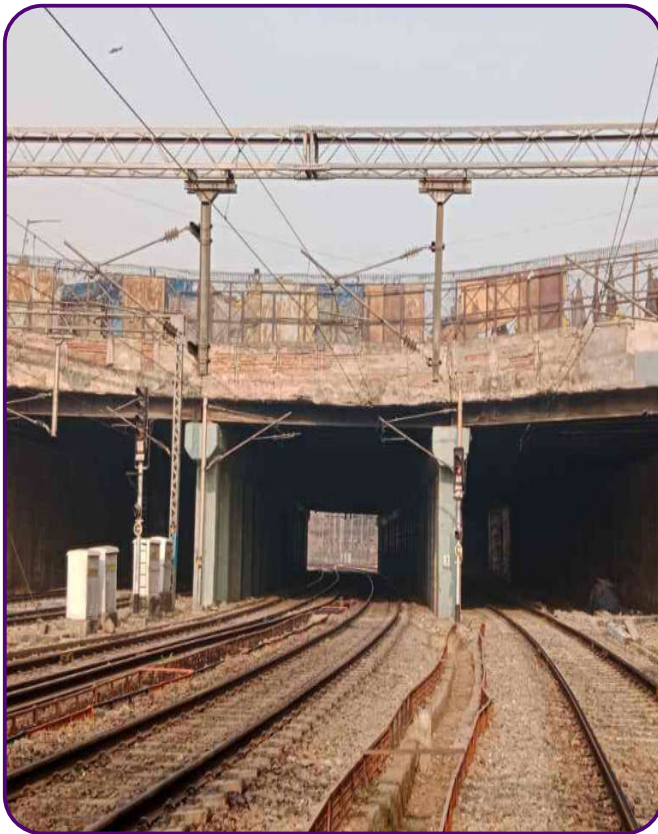
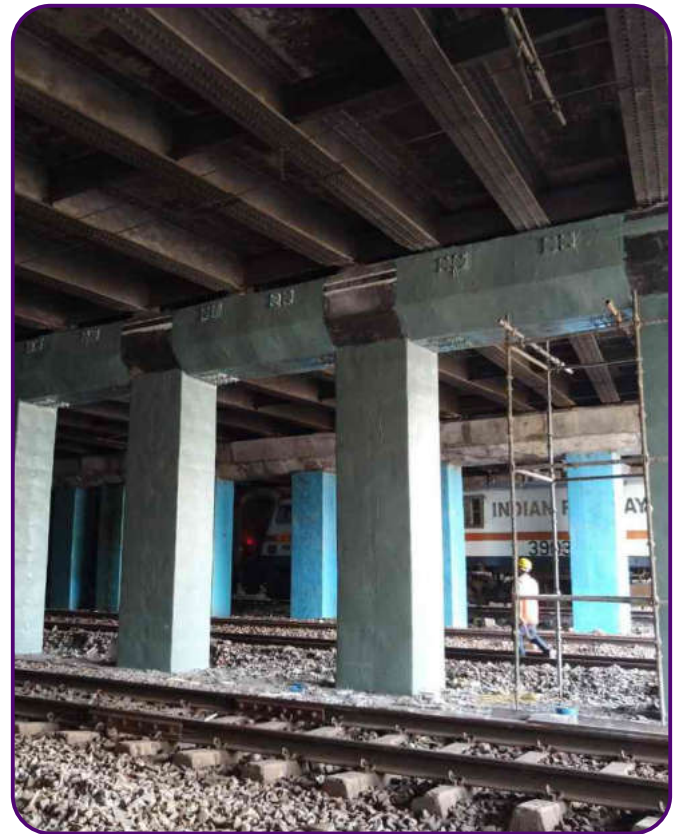
## Rail Over Bridge At Delhi.

- Working on transportation infrastructure requires a keen understanding of the unique challenges, demands, and requirements of these structures. These range from the importance of maintaining access, minimizing disruption, and maximizing safety to the need to optimize the quality and performance of infrastructure repairs that must stand up to public use for decades. Keeping all these requirements in a note, DGC has done rehabilitation of 40 years old ROB
- The strengthening was done by using various repair methods such as jacketing, fibre wrapping, anti-corrosive treatment, Anti Carbonation Treatment, strengthening with pre-stress Laminates & Polymer modified mortar treatment at the distressed area.

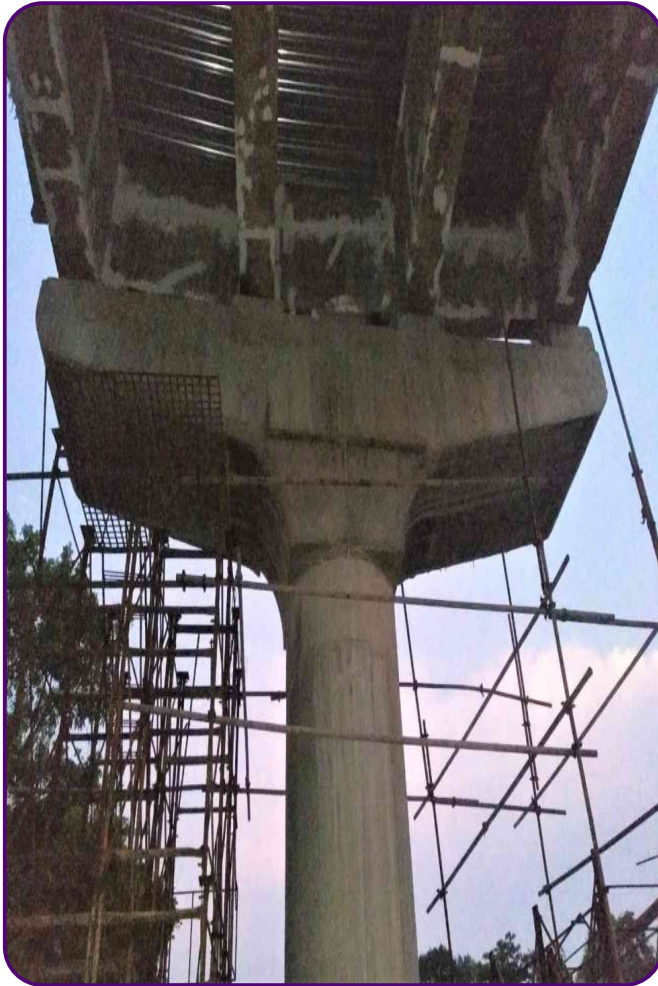
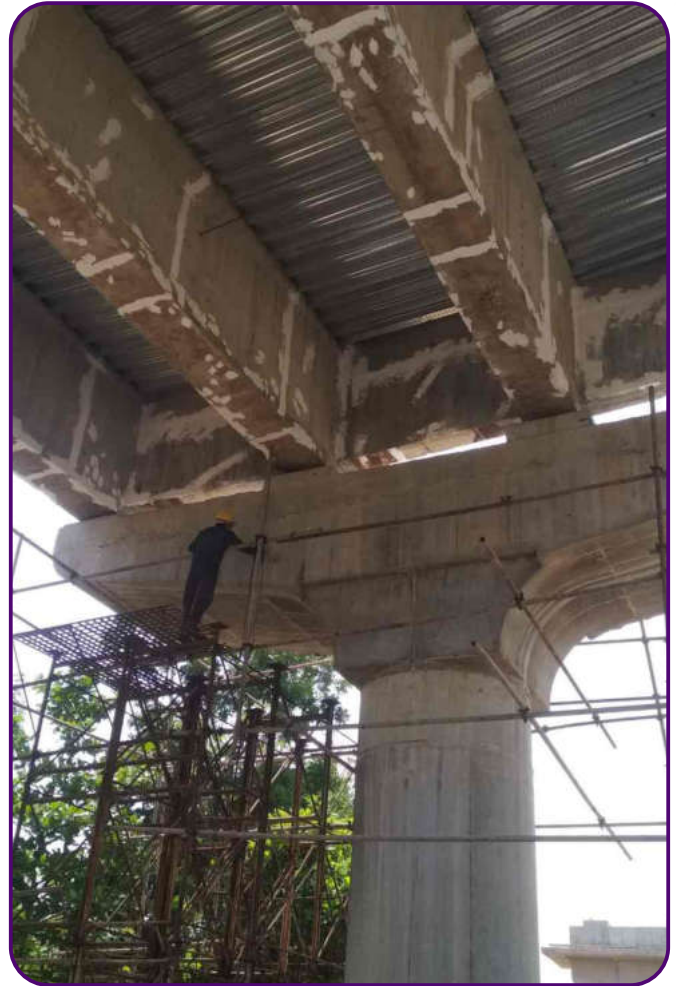
## Bridge Pier Cap At Alappuzha Kerala.

- A bridge on NH-47 from Km 408+100 to Km 414+900 in the state Kerala, required strengthening of pier cap in P82 pier. The change in the alignment of the span due to presence of railway track at site, lead the spanning girders skewed. Hence, there was necessary to strengthen a pier cap for additional shear capacity

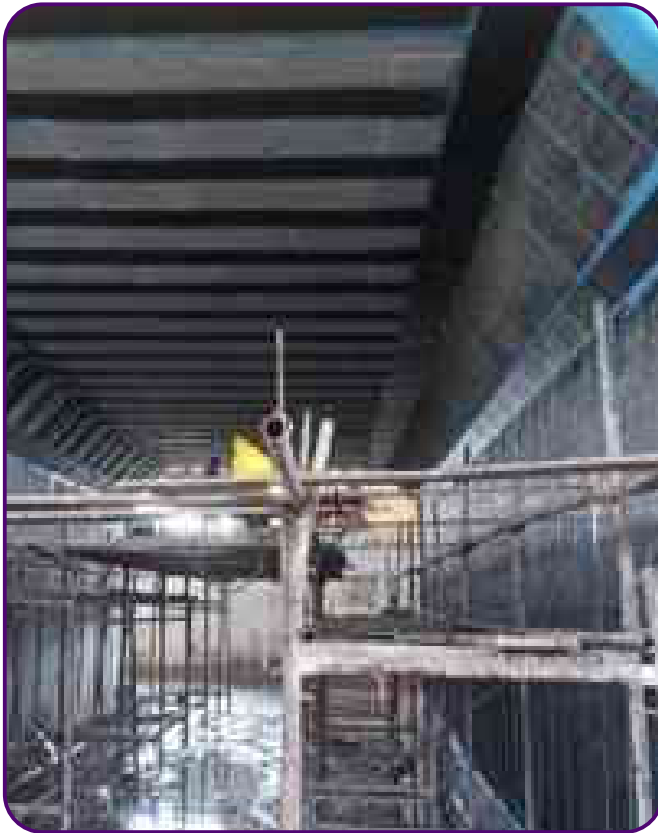
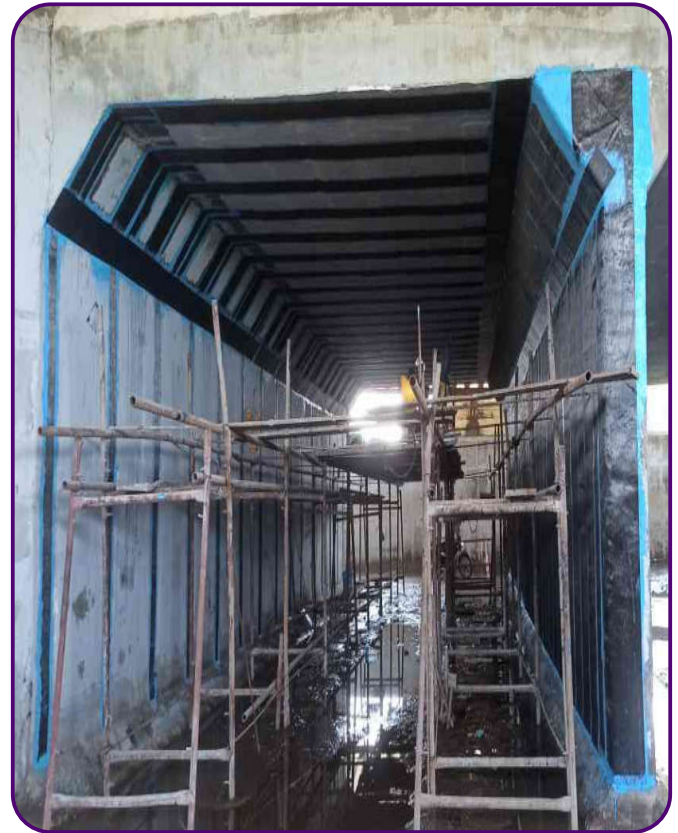
## Twin Cell Box Bridge, Dabhoi

- A condition assessment of 3-year-old Rail under Bridge (RUB (Twin Box) structure located in Dabhoi, Gujarat revealed deficiency in the grade of concrete. Hence, there was a requirement for the rectification work
- The structure was strengthened using CFRP Bands without affecting the train traffic on top of it. The demonstration showed that the structure is safe under static deflection and dynamic deflection as per codal provisions.

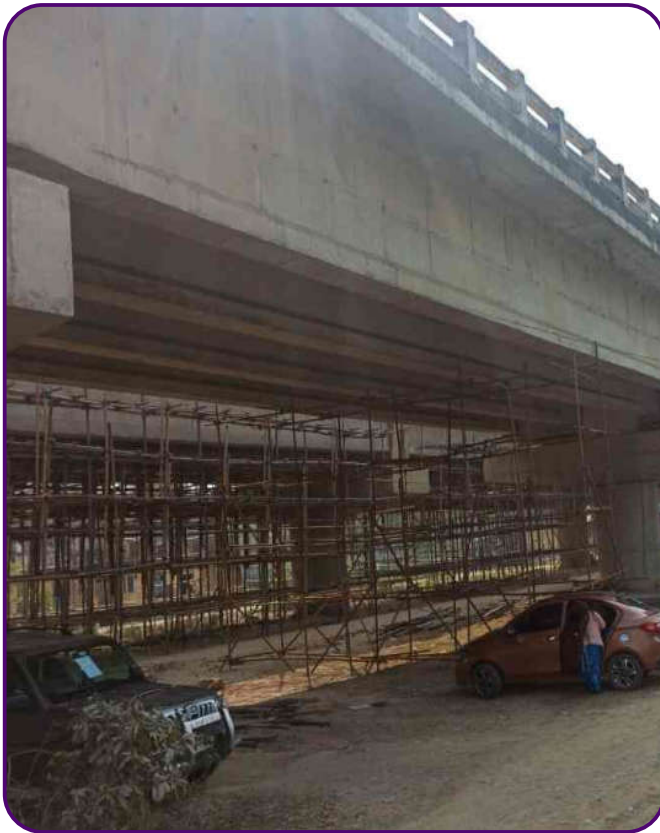
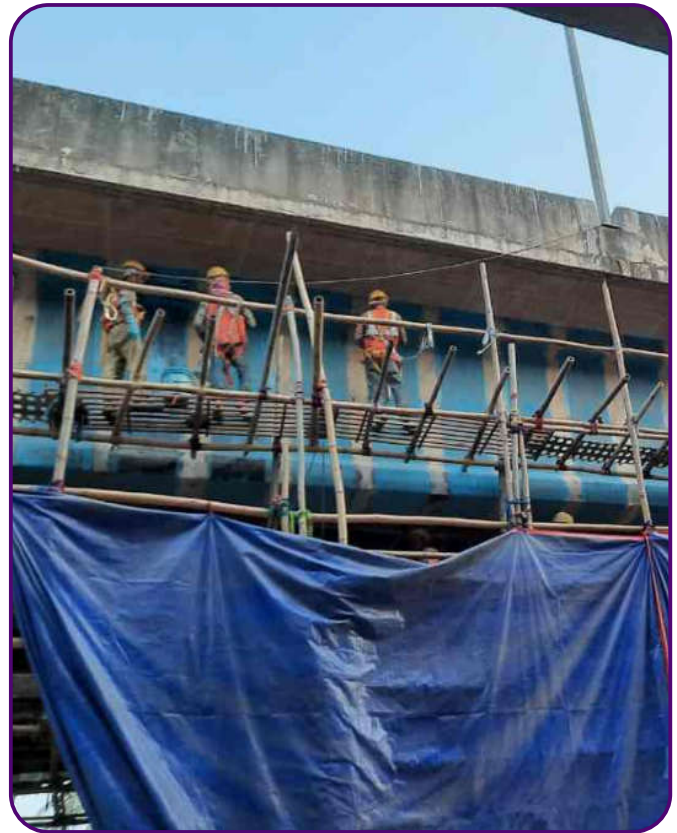
## RC Girder Bridge, West Bengal

- The bridge is located between Farakka and Raiganj Section of NH-34 (Package 4) in Malda District. There are separate bridges of two lanes in each up and down directions. Each bridge consists of eleven spans of 28m length. The superstructure of each bridge consists of four numbers of RC longitudinal girders with composite RC deck slab.
- Pre-stressed laminates are used to strengthen the girders for their flexural capacity followed by CFRP wraps to improve their shear capacity. Further, the complete system is protected by providing vermiculite plaster applied by the method of guniting.

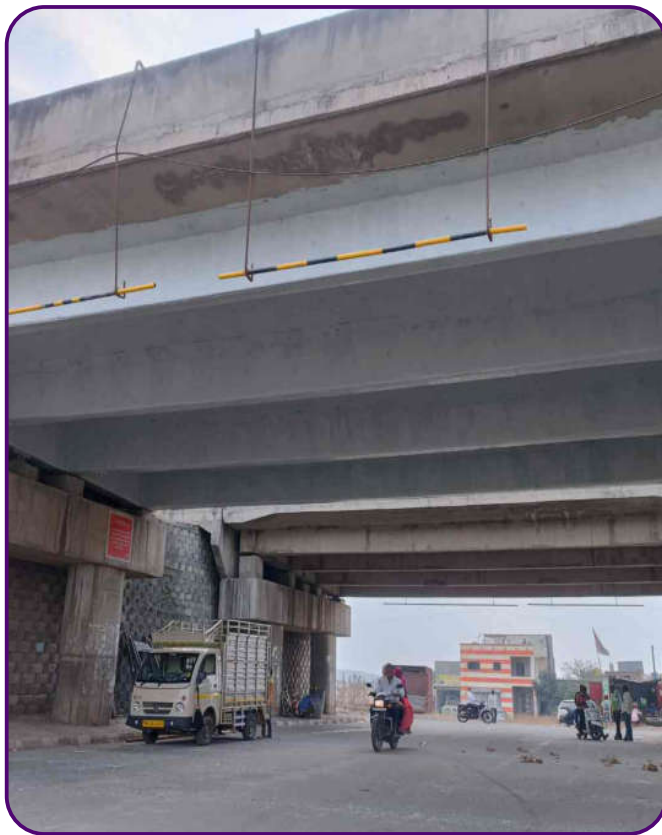
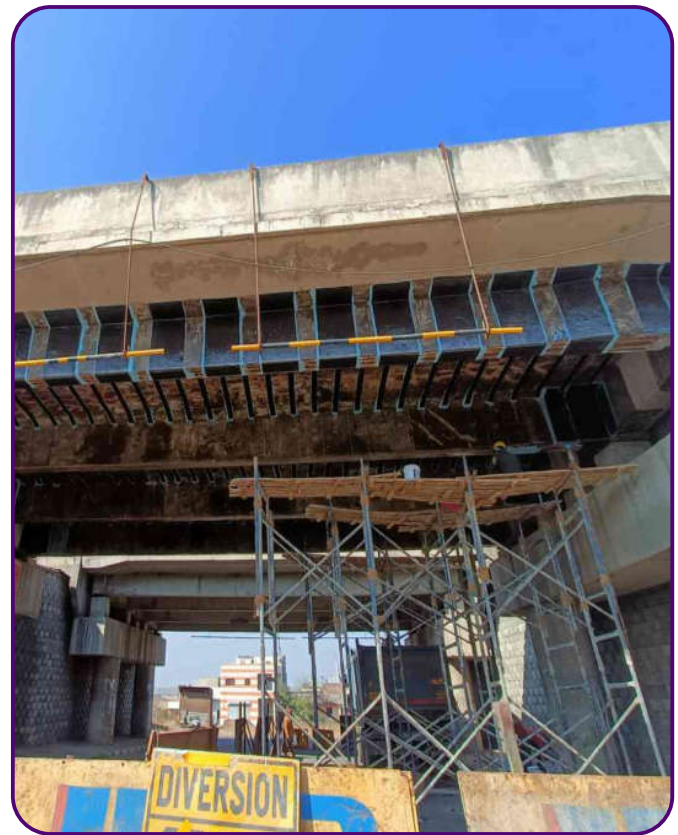
## RC Girder Bridge In Solapur, Maharashtra

- The Vehicular under pass located at Solapur, Maharashtra is a RCC Girder and Deck Slab. It was observed that the quality of concrete in girders and Slab was poor and thus it required strengthening.
- There were restriction for the high axle load vehicles hence the bridge girders are strengthened using combination of Pre-stress and Non Pre-stress laminates. Further the deck slab is strengthened using CFRP Bands. Bridge is now allowed for its regular use.

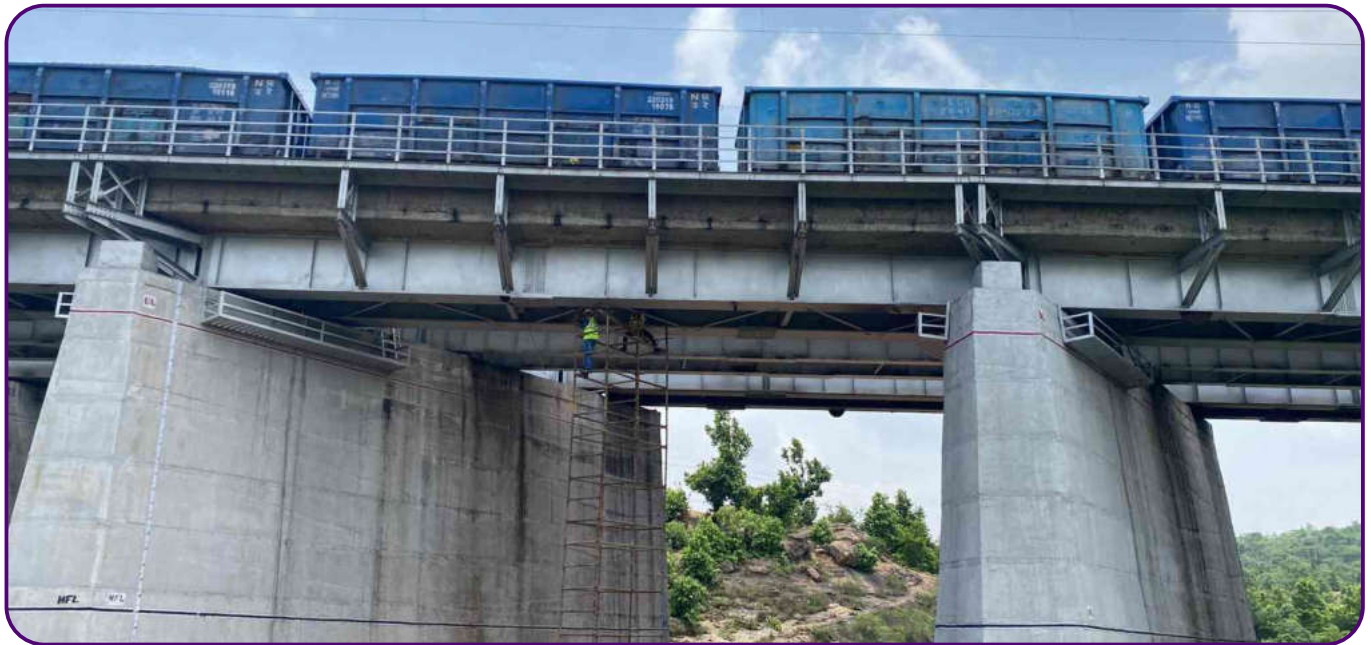
## B. STEEL GIRDER BRIDGE IN SINGRAULI

- Client: - SGS
- This Bridge Located in Madhya Pradesh consists of three spans of  $2 \times 29.4 \text{ m} + 1 \times 18.46 \text{ m}$  of composite steel girders having RC deck slab. This bridge is designed for 25t loading. Load Testing of the Bridge was carried out to check whether the super structure of this bridge is safe to carry 25t loading as defined in IRS bridge code and whether the structural performance is acceptable in-service condition.

- After the successful completion of Tests, Bridge was approved for 25t class loading and higher axle speed as deflections and strains measured at site are slightly less than results obtained from FE model. The Static and Dynamic deflections were found to be within 15% of analytical estimations.

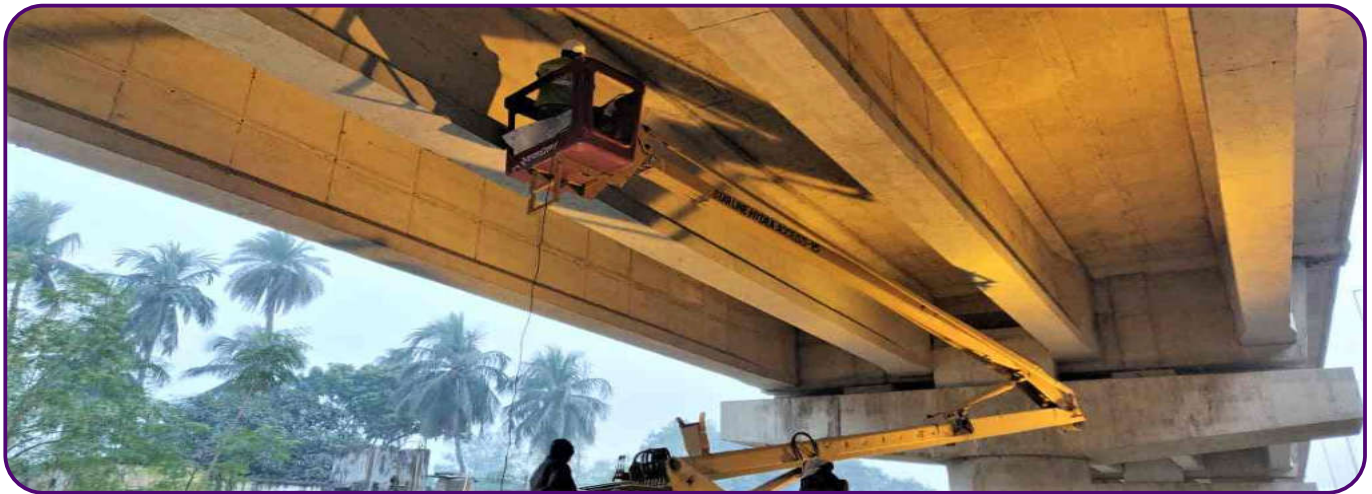
- The bridge was constructed and opened for road traffic in 1989. It was observed that there is excessive vibration in the deck of bridge. This vibration can be easily felt during the passage of vehicles over it.

- Static load tests were performed to know the behavior of girders in flexure under live loads. Two loaded trucks, each weighing 32 tonnes, were used for performing load test. Axle load distribution and load configuration of the loaded test trucks used for static loading.

- Dynamic load tests: - Natural frequencies of the superstructure were measured by installing accelerometer on the deck. The accelerometer was installed at the bottom of the girders. The deck was excited by getting a vehicle passed over the deck. The response under free vibration were measured in time domain. The response was then converted into frequency domain by using Fast Fourier Transform, FFT.

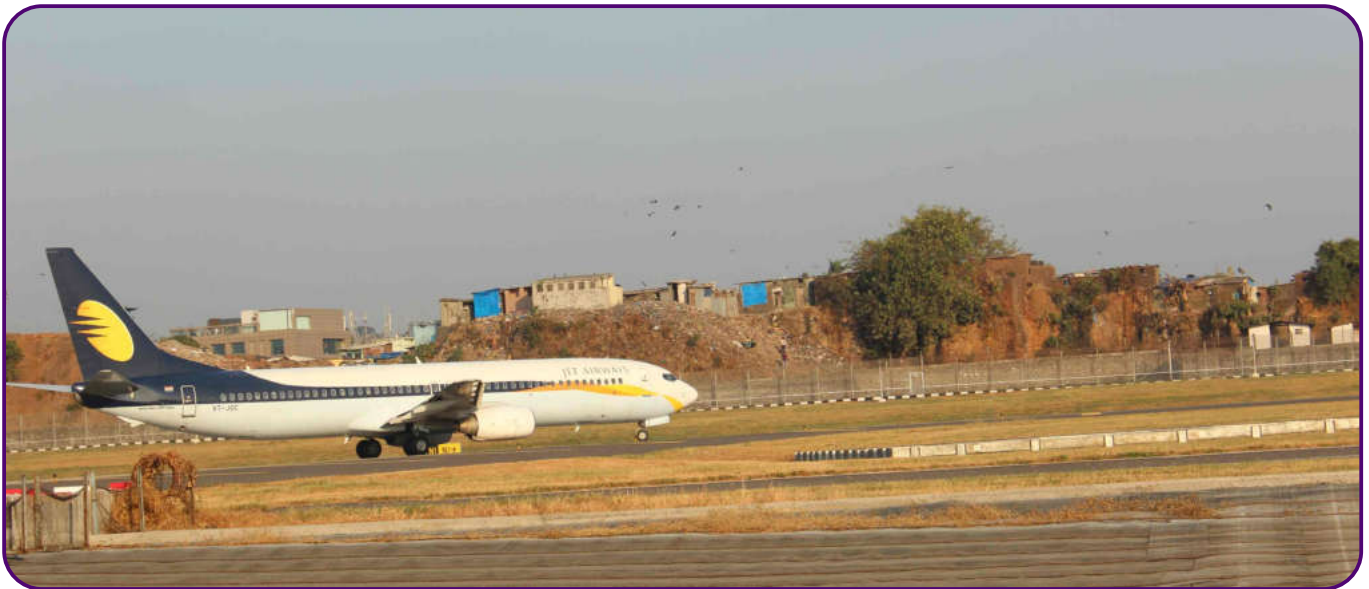
## D. CONDITION SURVEY OF TAXI-WAY FOR AIRCRAFT LOAD

- A Taxi-way bridge located inside Mumbai International Airport over Mithi River was designed for smaller aircraft loads but the loads of currently designed aircraft are slightly higher hence the condition assessment of Taxi – Way was proposed.

- During the initial Stage extensive Visual Inspection was carried out inside the Box Girder along with Crack Mapping of all the bays. Strain Gauges and Linear Potentiometers were mounted below the Taxi – Way. Mounting the sensors was a critical task owing to sludge, impure water and insects of Mithi river.

- As the Heavier aircrafts arrive during night time the entire testing was conducted during Night and the derived results were submitted to the client along with the strengthening scheme.

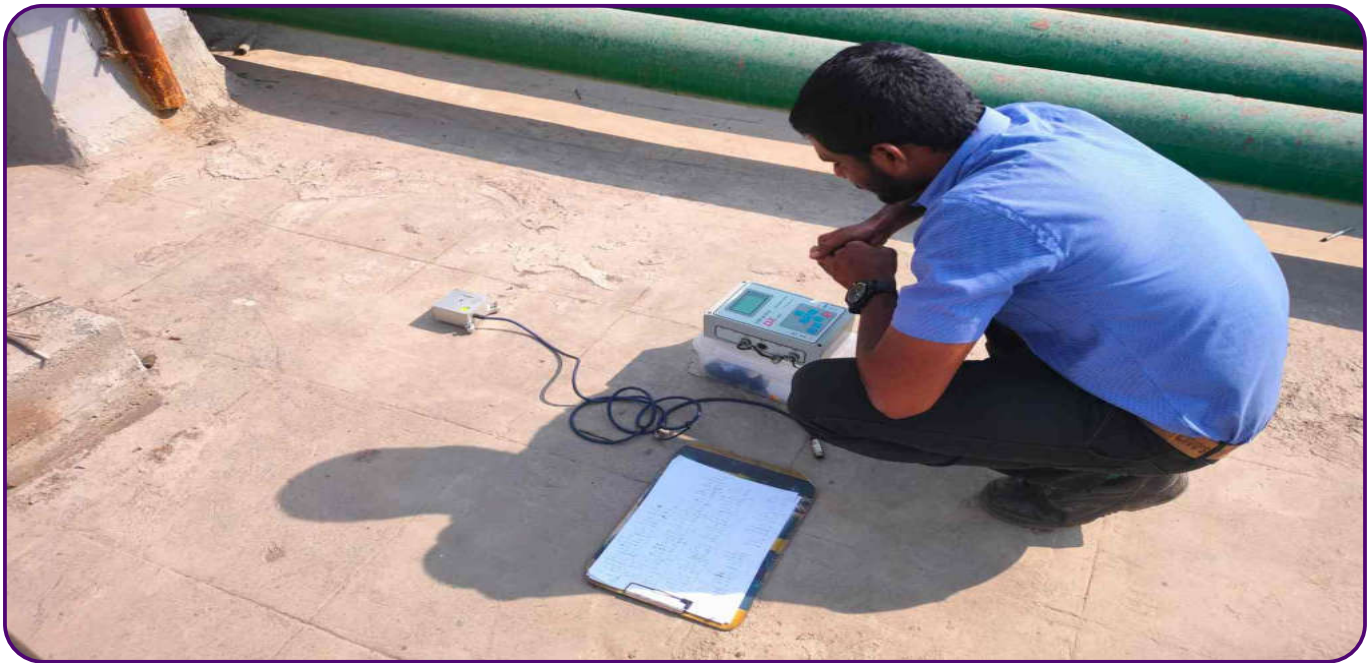
## E. SHORT TERM DYNAMIC MONITORING OF ASEPTIC & MILK PROCESS BUILDING

- A systematic protocol developed and implemented for observing, tracking and logging data over a period of 100 hours in order to characterize the health state of structure and to detect any possible change due to occurrence of damages.
- The proposed accelerometers monitor triaxial acceleration without any wires. The sensors can calculate natural frequency of the building and detects shift in Natural frequency.
- The present structure is an Industrial building constructed with RCC which has previously undergone a structural audit. Based on accurate investigations and analyses, the building pathology is diagnosed and adequate consolidation methods.
- Temperature, Tilt and Vibration sensors were mounted in the factory and all the critical measurements were recorded and a detailed analysis report was submitted to client.

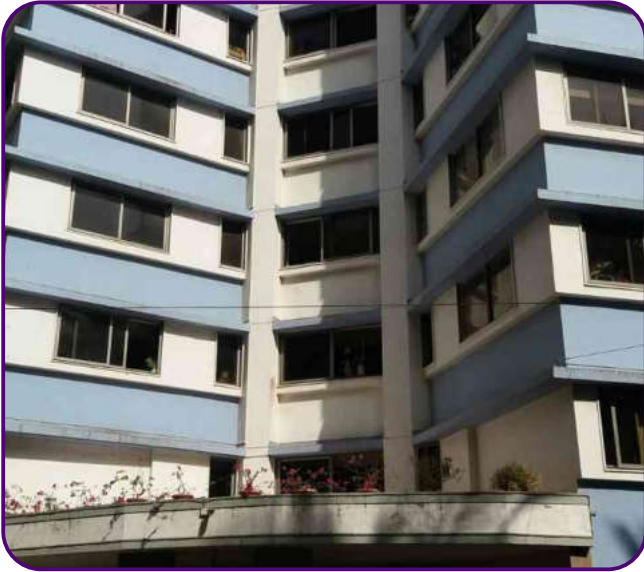
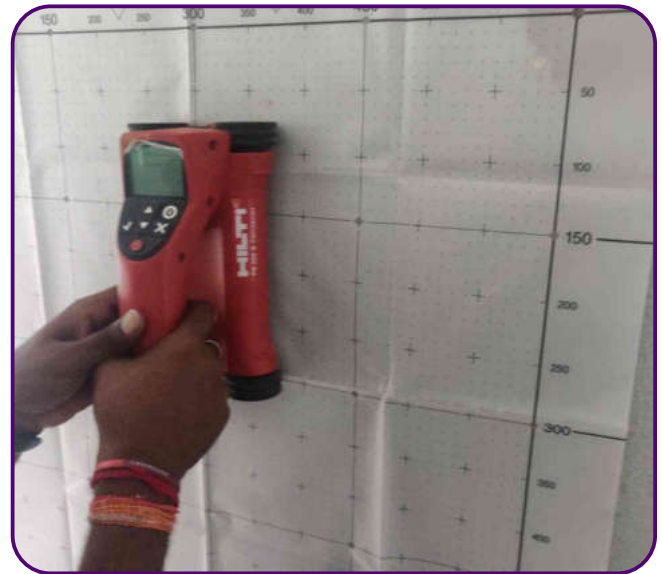
## RESIDENTIAL BUILDING

- Miami Apartments is an approximately 50 years old Structure Located in Mumbai. It is a G+13+Terrace RCC Structure. The Client wanted to carry out Structural Audit of the building to find out the current Condition of the building.

- Advanced NDT methods like CAPO Testing and Rebar Scanning were carried out on site to determine the in-situ Compressive Strength and Rebar Details of reinforcements in columns, beams, and slabs.

- External and Internal damages were noted down during the visual inspection of the building.
- Non-Destructive tests were carried out using Rebound Hammer, UPV, half-cell potential test, Carbonation, CAPO Test, Chemical test and Rebar Analysis was carried out stagewise.
- A structural analysis report was prepared and submitted to the client for future course of action.

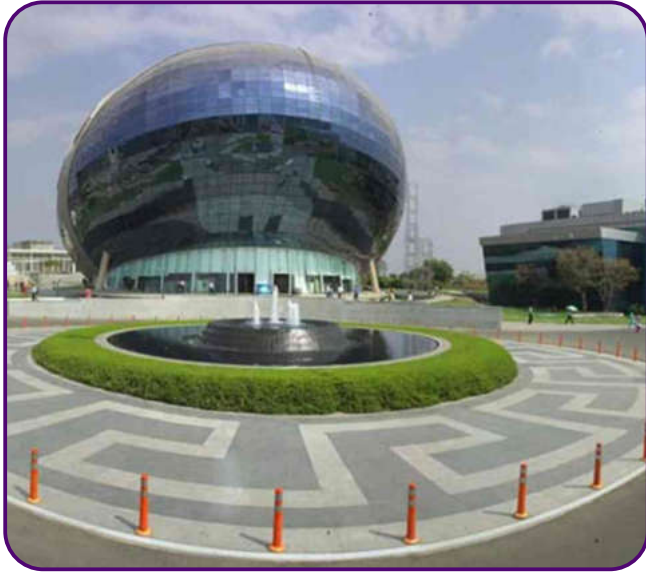
## COMMERCIAL BUILDING

- Foundation details were not available hence Ground Penetrating method was used on site which uses radio waves to capture images below the surface of the ground in a minimally invasive way.

- The G+5 commercial building located in Pune consists mostly of working platforms and cabinets. Requirement of Condition assessment of the building arose due to visible Cracks on the columns and Beams.

- **Stage 1** Visual inspection of the entire building was carried out to note down the damages, crack mapping was performed throughout the building, Foundations were exposed to check for any distress signs.

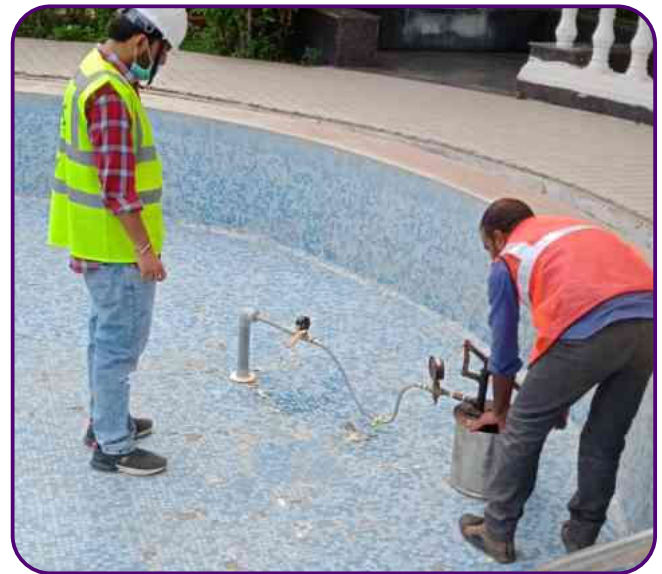
- Condition Assessment of Swimming pool, which is a part of officer's club in Delhi was done due to Leakages and cracks observed by the client. The swimming pool was non functional for the past 2 years.

- During the Initial stage Extensive Visual Inspection was carried out for the entire swimming pool along with Pump room and Pool electrical inspections.

- Thermal Imaging took place on site. Thermal image capturing makes leak detection more efficient and simpler as it identifies the problem areas that cannot be seen with the naked eye. Non-destructive testing methods were used to evaluate concrete properties by assessing the strength and other properties such as corrosion of reinforcement, cracking, and integrity of concrete.

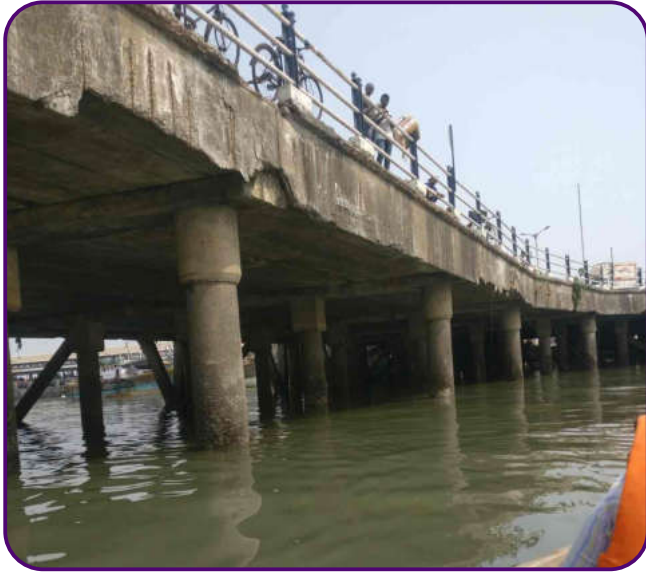
## FERRY WHARF JETTY

- Tide calendar was observed while carrying out the Non-Destructive Testing and the Structures were investigated grid by grid for ease in observations.
- A strengthening scheme along with Design Calculations was proposed with the height barrier restriction to restrict the passage of any heavy vehicles on jetty.

- Bhaucha Dhakka is a wharf along the coast of dockyard road on the eastern seafront of Mumbai. The Wharf serves as the port for numerous fisherman who bring in their daily catch. Ferry services link up JNPT, Uran to the east, Rewas and Mandwa to the south.

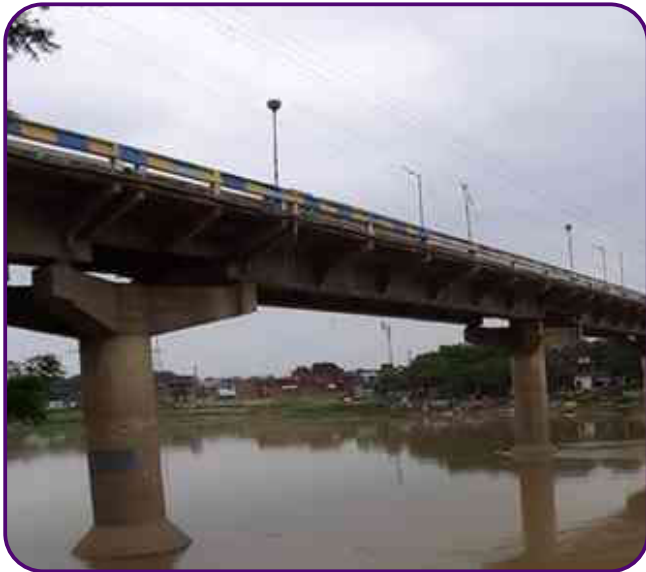
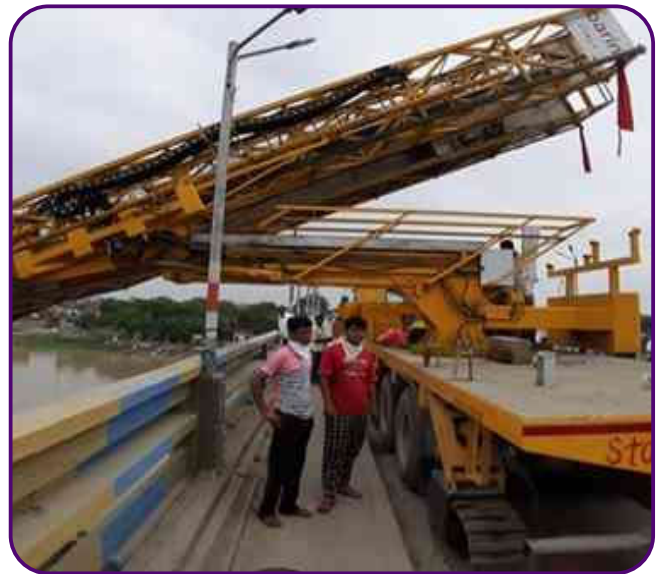
## STRUCTURAL AUDIT OF BRIDGES

- Visual Inspection and Non-Destructive Testing was carried out for 20 Bridges Located in Uttar Pradesh.
- Exclusive Non-Destructive Testing Including Core Testing, Rebound Hammer, Ultrasonic Pulse velocity, Half Cell Potential Test, Carbonation and Rebar Scanning was carried out on the Bridges.

- Designing of strengthening scheme Preparation of strengthening scheme on the basis of results of Non-destructive Test was submitted to the client.
- The Whole Testing procedure was carried out with the help of Mobile Bridge Inspection Bridge unit .
