# **SPECIALIZED ENGINEERING AND CONSTRUCTION COMPANY**

# COMPANY PROFILE

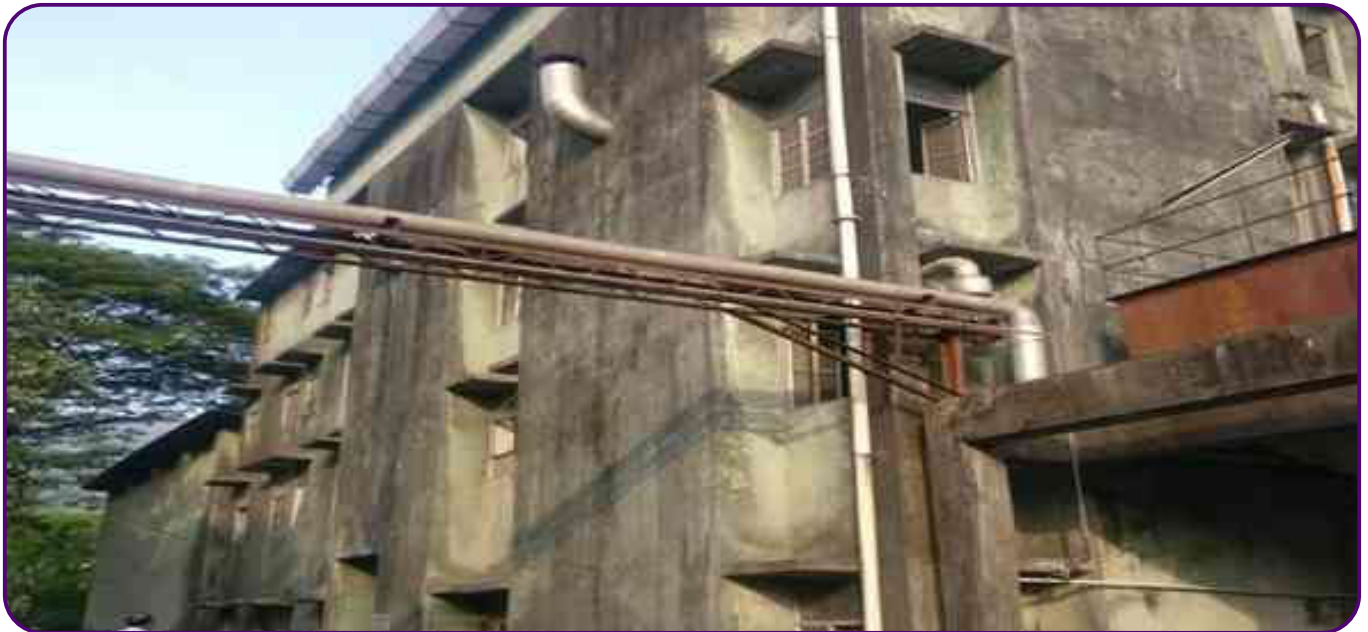
# CONDITION ASSESSMENT OF MANUFACTURING PLANT

- Mohan Rocky Spring Water Breweries Limited is an Indian-based Breweries manufacturing company.
- One of the oldest breweries manufacturing plant is in Maharashtra. Which majorly manufactures breweries of the mainly alcohol and other product.
- Condition Survey was carried out to examine concrete for the purpose of identifying and defining of distress.
- The Objective of Condition Survey of a building structure is:-
  - a) To identify - cause of distress and their sources.
  - b) To assess
    - the extent of distress occurred due to corrosion, fire, earthquake or any other reason,
    - The strength of the structure,
    - Its ability for rehabilitation
  - c) To prioritise the distressed elements according to seriousness for repairs and
  - d) To select and plan the effective remedy

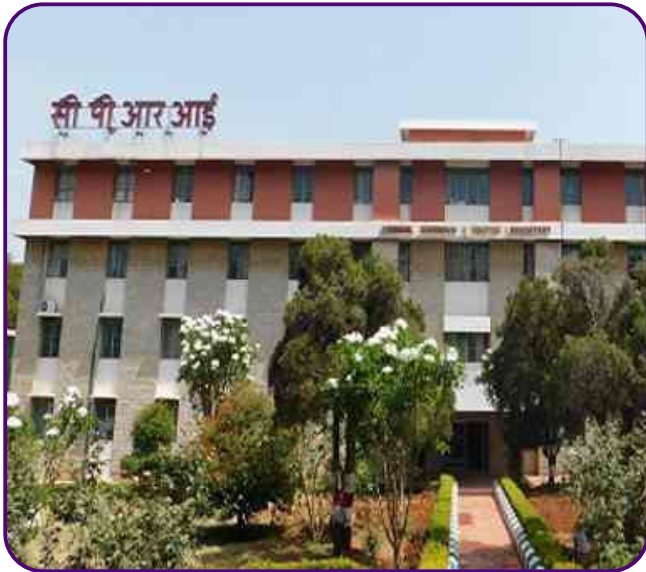
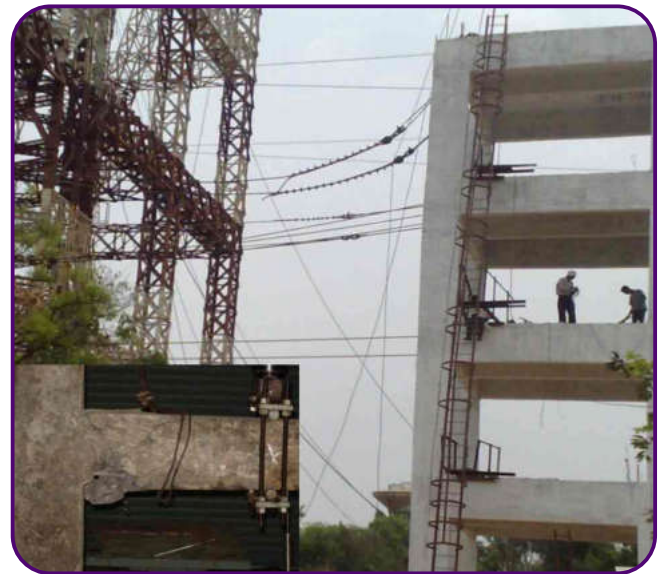
## A. TEST WITH CPRI (ONE OF A KIND TEST IN SOUTH-EAST ASIA)

- Distressed: The structure was damaged till its plastic limit, major cracks at join and columns, the bars were broken, the structure shown some permanent deflection which was pulled back to some extent from the other side's repair by grouting, micro Concrete, PMM done by specialized agency BINYAS ,Bangalore.

- Theme: Aim of test find the solution for lateral load capacity enhancement using composite CFRP (carbon Fiber Reinforced polymer) wrap and laminate at junction
- Test conducted: The structure was subjected to 90% distress with cable string at each floor level laterally to stipulate pushover test or earthquake load.
- Strengthening: CFRP laminate and wrap at the junction confined by a specialized agency R&M International Result after testing: the structure regain its original strength by 90%

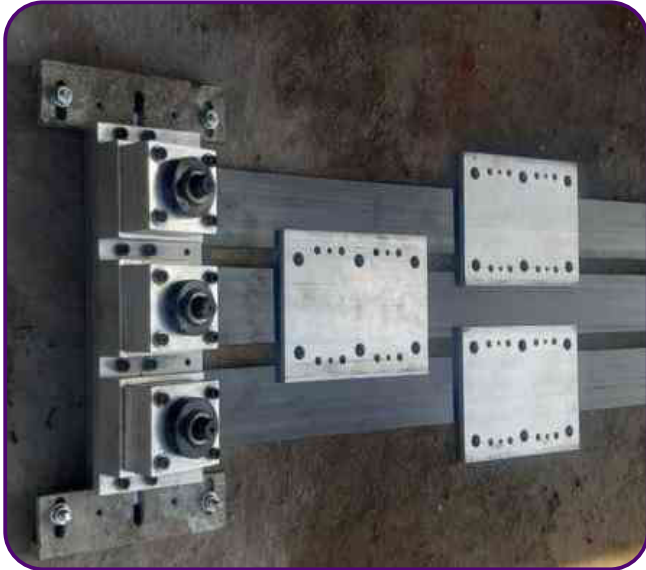
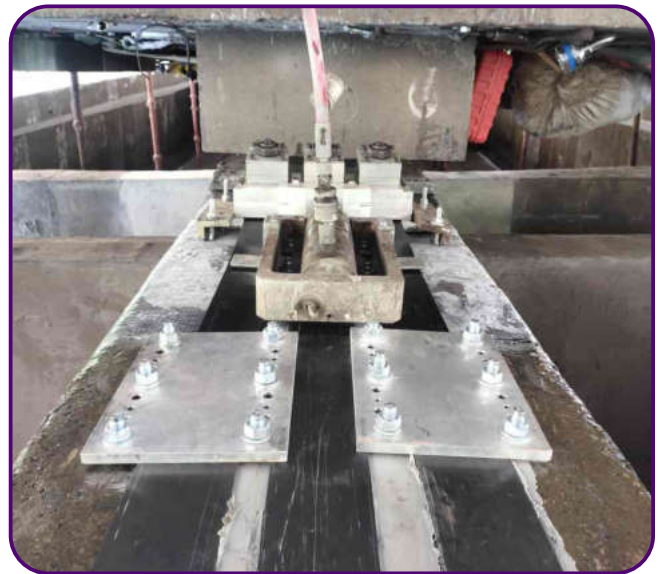
## B. TECHNOLOGY OF TRIPLE STRESSING

- A tensile force of magnitude as suggested by the designer is applied on the laminates gradually at the rate of 0.5 tons per min on each of the laminate in the system. Once the designed load is given and the strains are induced in the laminate with the same magnitude the system of loading need to be stopped and retained for about 12 hrs (generally) until the adhesive gets dried and develops bonding conforming to ASTM D 4541 using stopper. The high grade metal plate, which is placed along with the machine need to be fastened before un-mounting the assembly. Test results were acquired and submitted for further Analysis.

- A specially designed machine which is portable and can be fixed on the substrate surface should have the capacity to accommodate at least three laminates in its width equally stressing the same. Adhesive applied conforming to ASTM provisions in its bonding properties to be applied on the laminates such laminates along with the adhesive adhered to the surface.

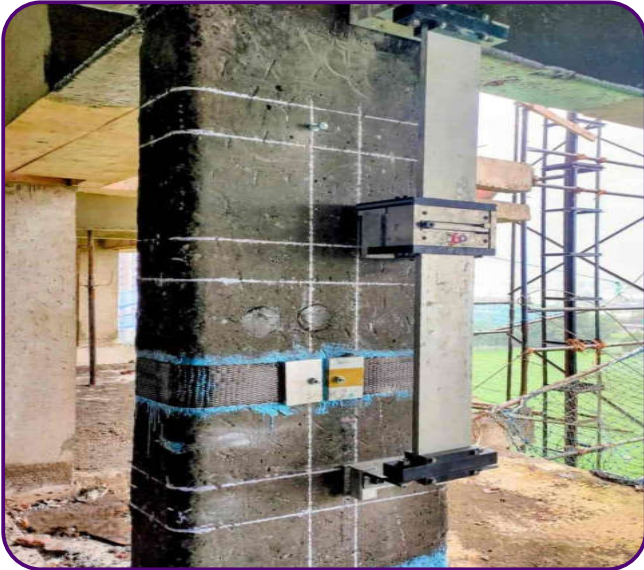
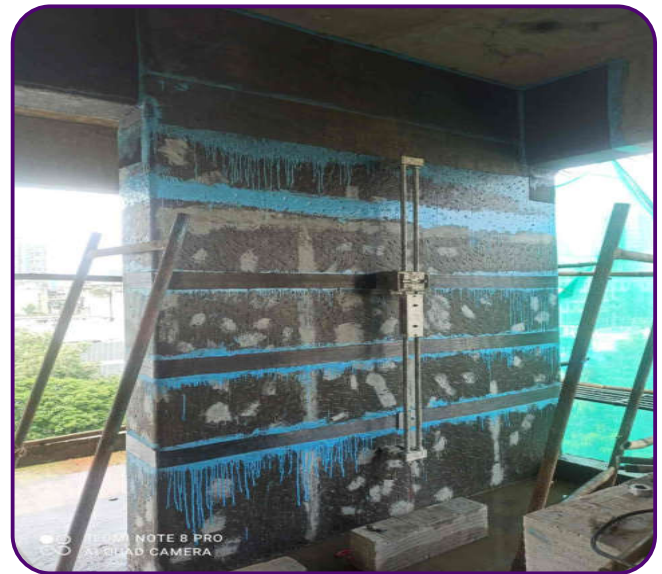
## D. TECHNOLOGY OF BAND PRESTRESS

- The FRP system is saturated by the bonding agent (generally epoxy based resin/saturant) the band is locked at one end and sufficient tensile force is given to the band as per the instructions given by the designer and then the stressed band is locked at the other end. Ensuring the FRP system is completely saturated allowed it to cure.

- In this phenomenon the FRP bands of known width need to be given sufficient tensile force so as to suffer controlled strain which is helpful in active participation of the same. The confining property of the CFRP system is significantly enhanced by these stressed bands.
